<b>MAJOR REPAIR AND ALTERATION</b> <b>(Airframe, Powerplant, Propeller, or Appliance)</b>		Form Approved OMB No. 2120-0020 <b>For FAA Use Only</b> Office Identification	
INSTRUCTIONS: Print or type all entries. See FAR 43.9, FAR 43 Appendix B, and AC 43.9-1 (or subsequent revision thereof) for instructions and disposition of this form. This report is required by law (49 U.S.C. 1421). Failure to report can result in civil penalty not to exceed \$1,000 for each such violation (Section 901 Federal Aviation Act of 1958).

1. Aircraft	Make	Beechcraft		Model	35-33
	Serial No.	CD		Nationality and Registration Mark	N638
2. Owner	Name (As shown on registration certificate)			Address (As shown on registration certificate)	
				P.O. Box 398 Cordell OK. 73632

Installed XeVision High Intensity discharge Xenon landing light lamp system in existing location of landing light in nose bowl.

Instructions for Continued Airworthiness  
For a Beechcraft 35-33 Aircraft  
With XeVision H.I.D. Replacement Landing Light in Nose bowl.

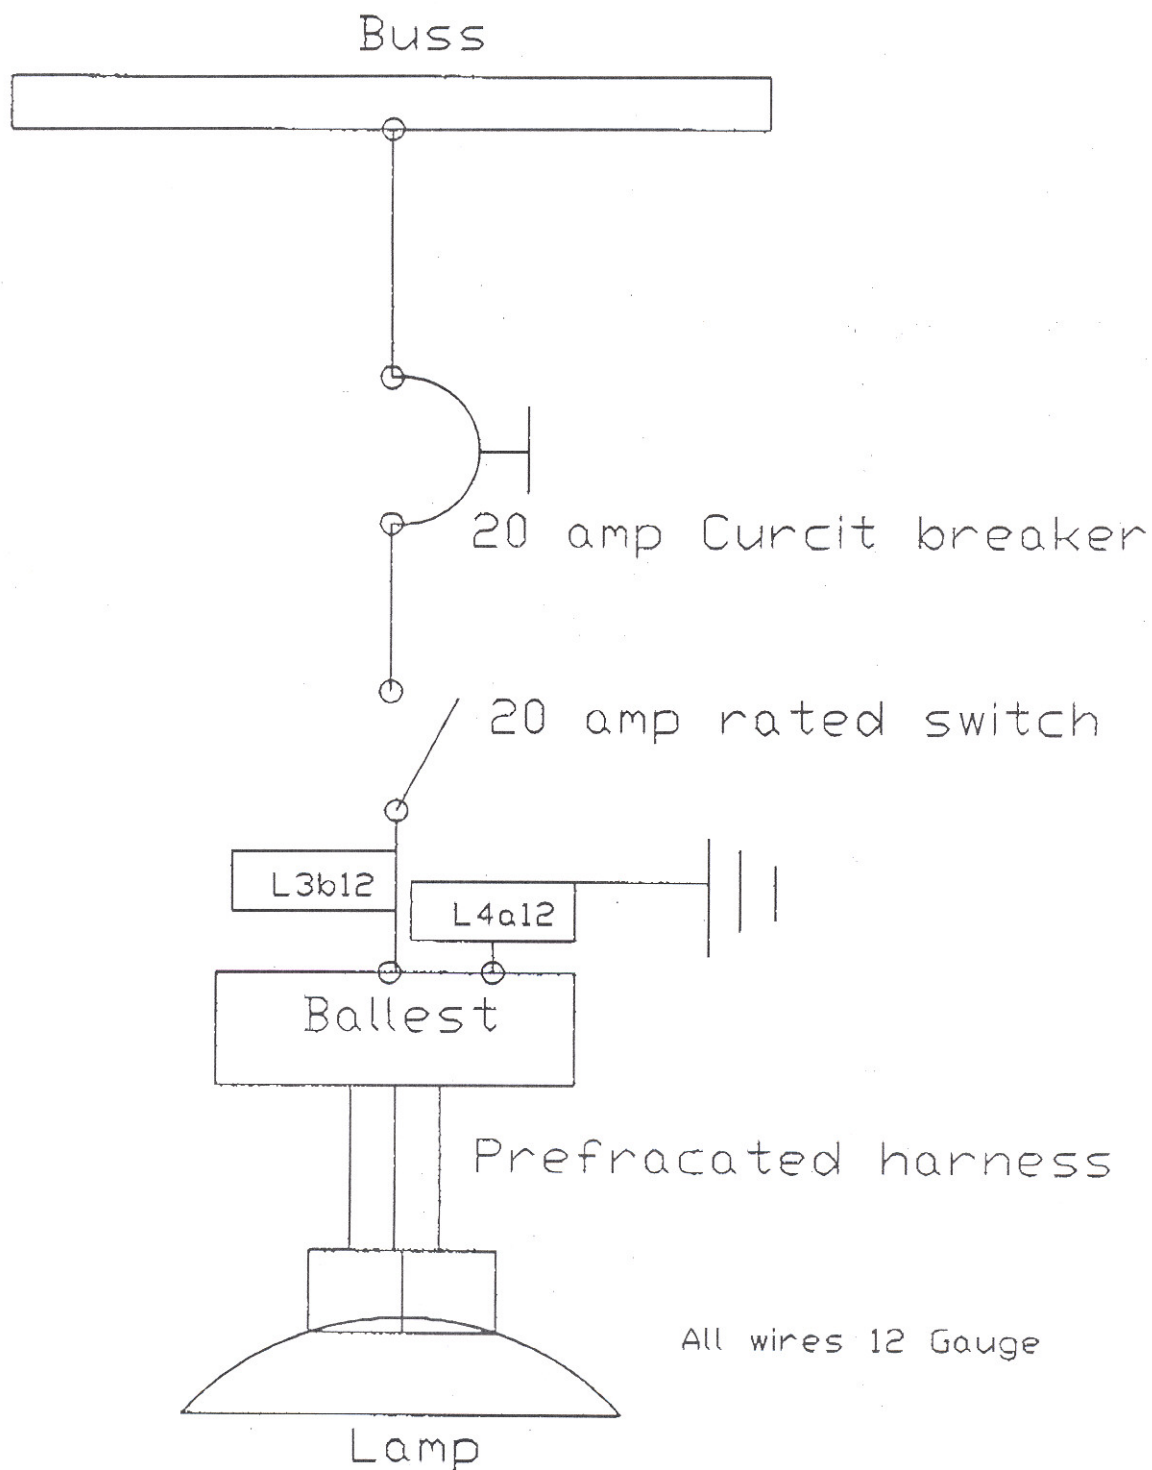
## Landing Light Wiring Diagram

5. Existing wiring from original light was retained as it exceeds the requirement of new light see attached drawing.
